Date	19/05/2016
Number	0682
Pages	8

### TECHNICAL INFORMATION

MODEL	MT09 / MT09A / FZ09 / MT09TRA / FJ09
SUBJECT	CAM CHAIN TENSIONER (CCT) NOISE

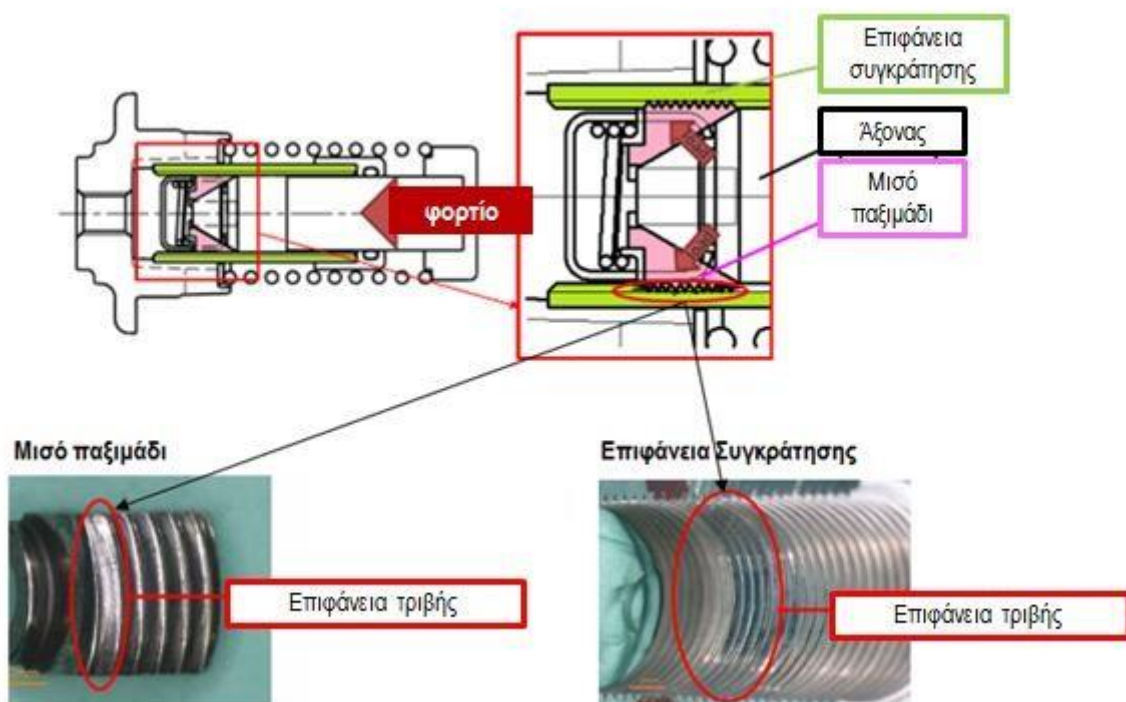
#### Tensioner Construction:

The contact between the threaded half nut and retaining surface damaged due to insufficient lubrication. The wear results in reduced friction and move the half-nut. As a result, the tensioner is not held taut and the chain oscillates causing noise.

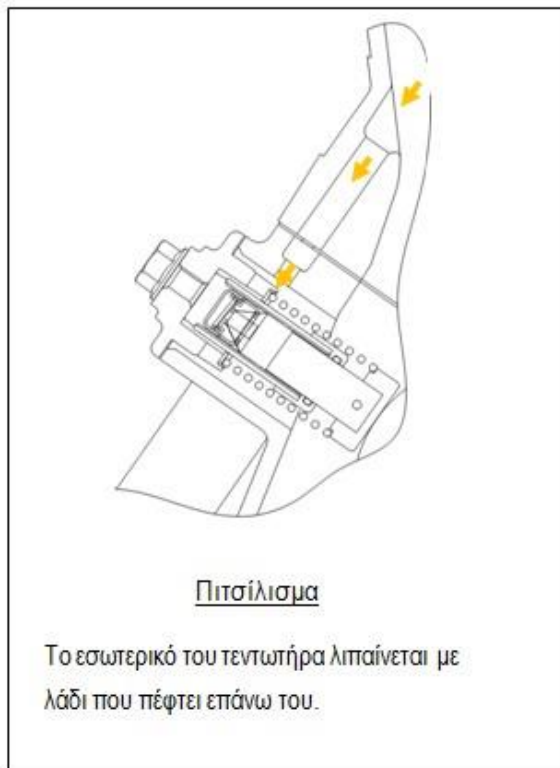
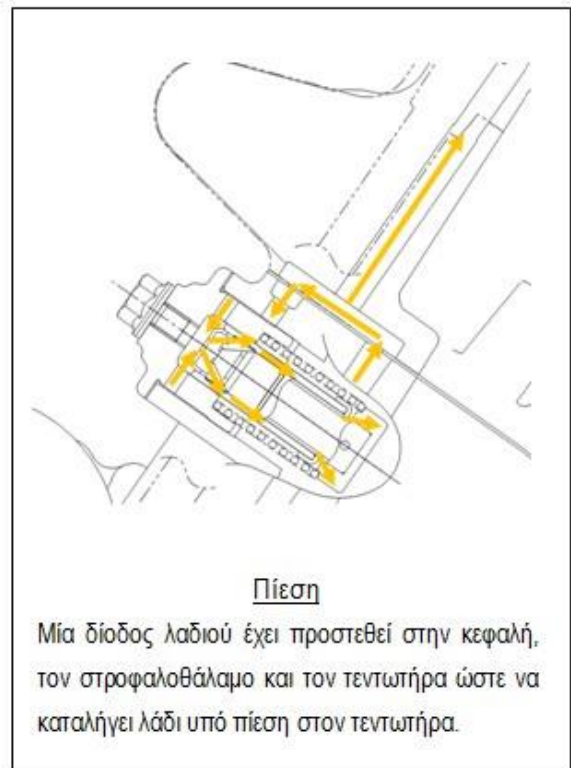
The way lubrication changed from splashing in pressure lubrication.

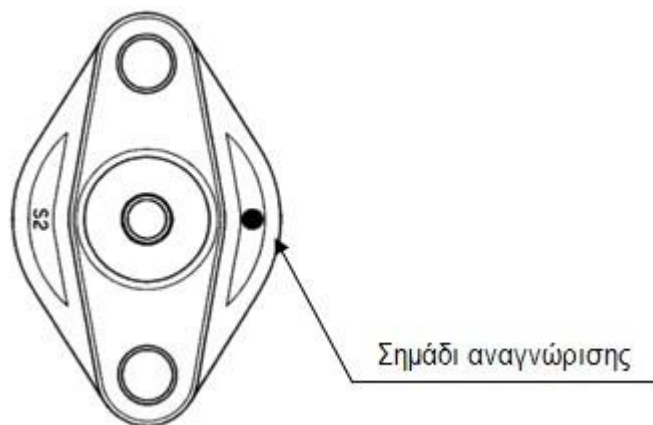
The color identification sign has changed

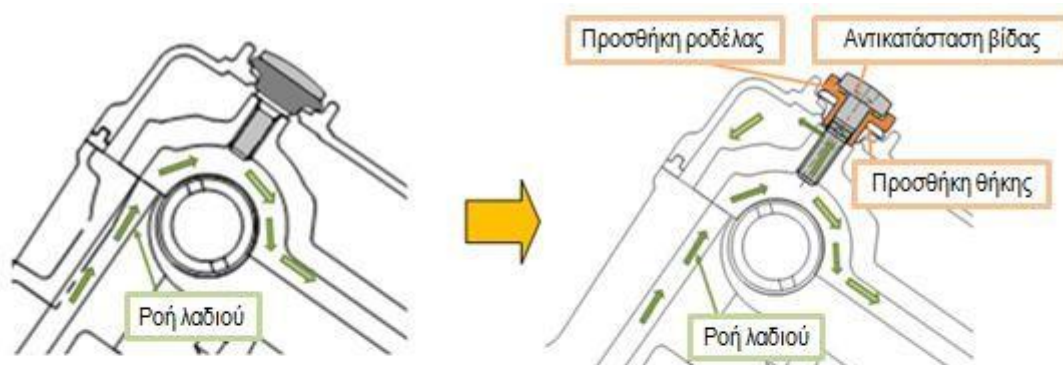
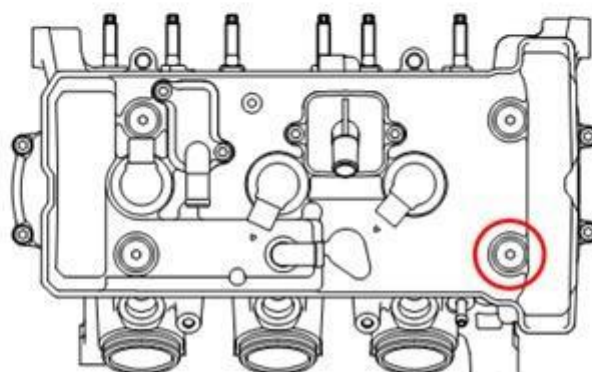
The existing oil flow is changed in a way that improves the lubrication of the tensioner.

One of the head cap screws is replaced with a bearing inner oil passage to convey oil from the easel camshaft on the roller.

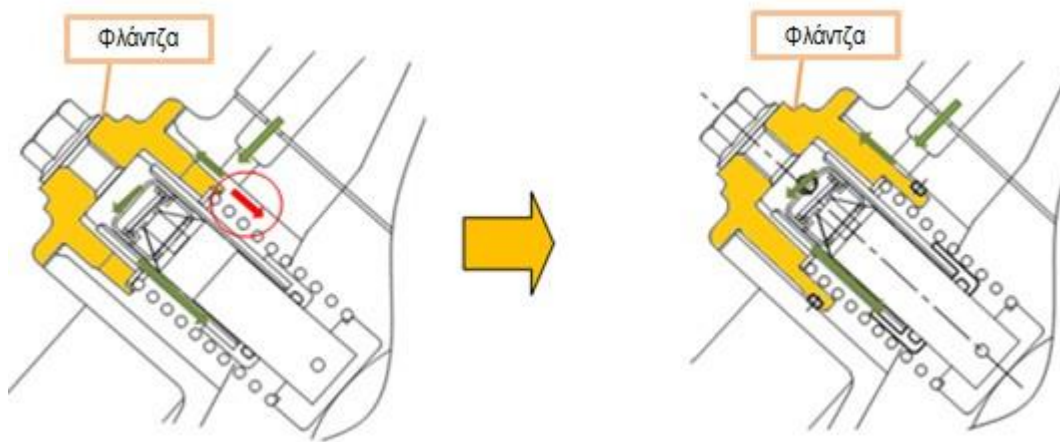
To effectively lubricated inside the tensioner, the inner flange of the tensioner grew to drive more oil in disputed wear point of the tensioner.

In case of a problem, replace the tensioner and place all the parts of improved kit.
