Technical BULLETIN

SOME 2014~2016 FZ09E/F/G AND FJ09F/G MODELS Cam Chain Tensioner Noise

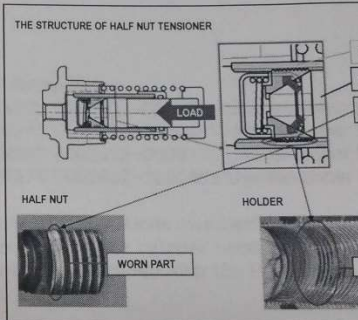
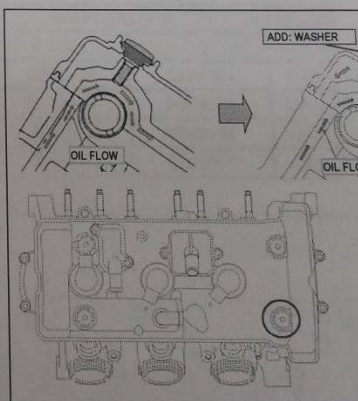
Cause: The threaded portion of the half nut and holder can wear due to insufficient lubrication within the tensioner. This causes reduced friction which allows the half nut to slip. If this occurs, the tensioner cannot maintain constant tension on the cam chain, resulting in noise.

Remedy: The oil passage inside the new tensioner has been modified to increase lubrication within the tensioner body and to the half nut and holder. One head cover bolt has been changed to a new design incorporating an oil passage to feed oil to the tensioner from the camshaft cap.
